Oil Fumes, Flight Safety, and the NTSB

Abstract: During its investigations into a series of ten aircraft crashes from 1979 to 1981, US National Transportation Safety Board (NTSB) officials were presented with a hypothesis that “several” of the crashes could have been caused by pilot impairment from breathing oil fumes inflight. The NTSB and their industry partners ultimately dismissed the hypothesis. The authors reviewed the crash reports, the mechanics of the relevant engine oil seals, and some engine bleed air data to consider whether the dismissal was justified. Four of the nine aircraft crash reports include details which are consistent with pilot impairment caused by breathing oil fumes. None of the tests of ground-based bleed air measurements of a subset of oil-based contaminants generated in the engine type on the crashed aircraft reproduced the inflight conditions that the accident investigators had flagged as potentially unsafe. The NTSB’s conclusion that the hypothesis of pilot incapacitation was “completely without validity” was inconsistent with the evidence. Parties with a commercial conflict of interest should not have played a role in the investigation of their prod

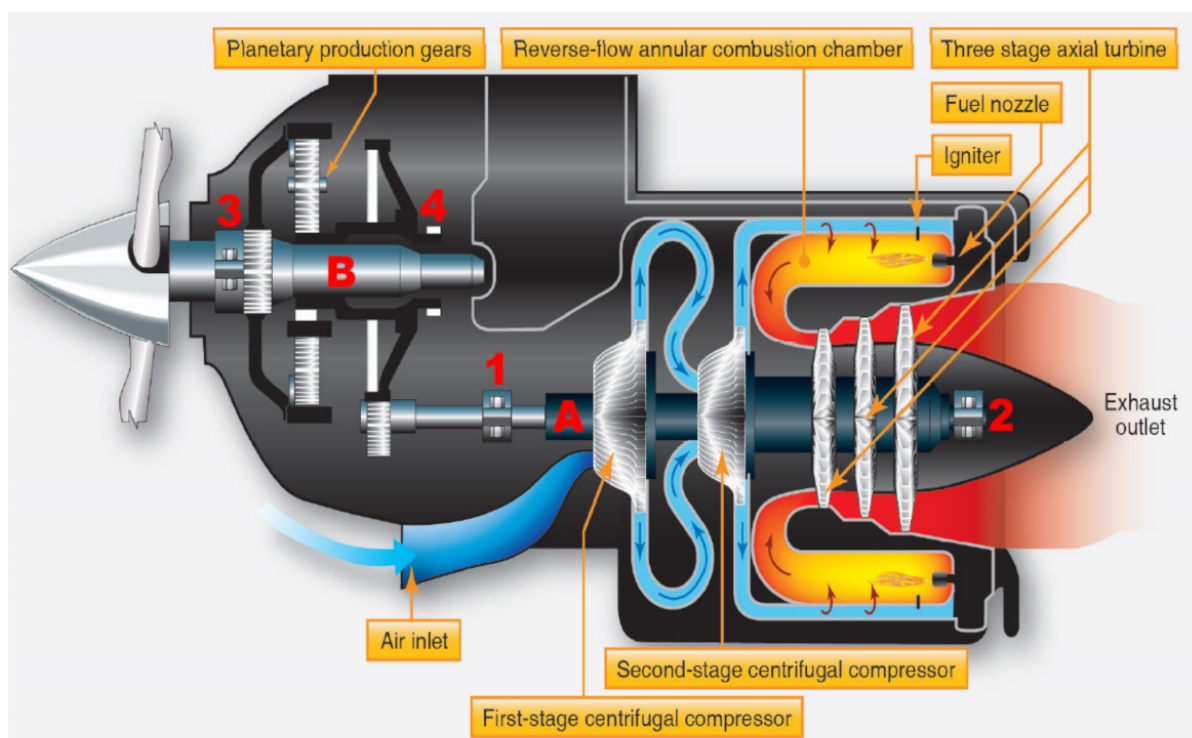
Figure 1. Garrett TPE331 turboprop engine (based on [18], p. 15-3). A. main shaft (engine shaft) with the gas turbine. B. propeller shaft with the reduction gear. 1,2. bearings that support the main shaft. 3,4. bearings that support the propeller shaft. 1. compressor bearing.

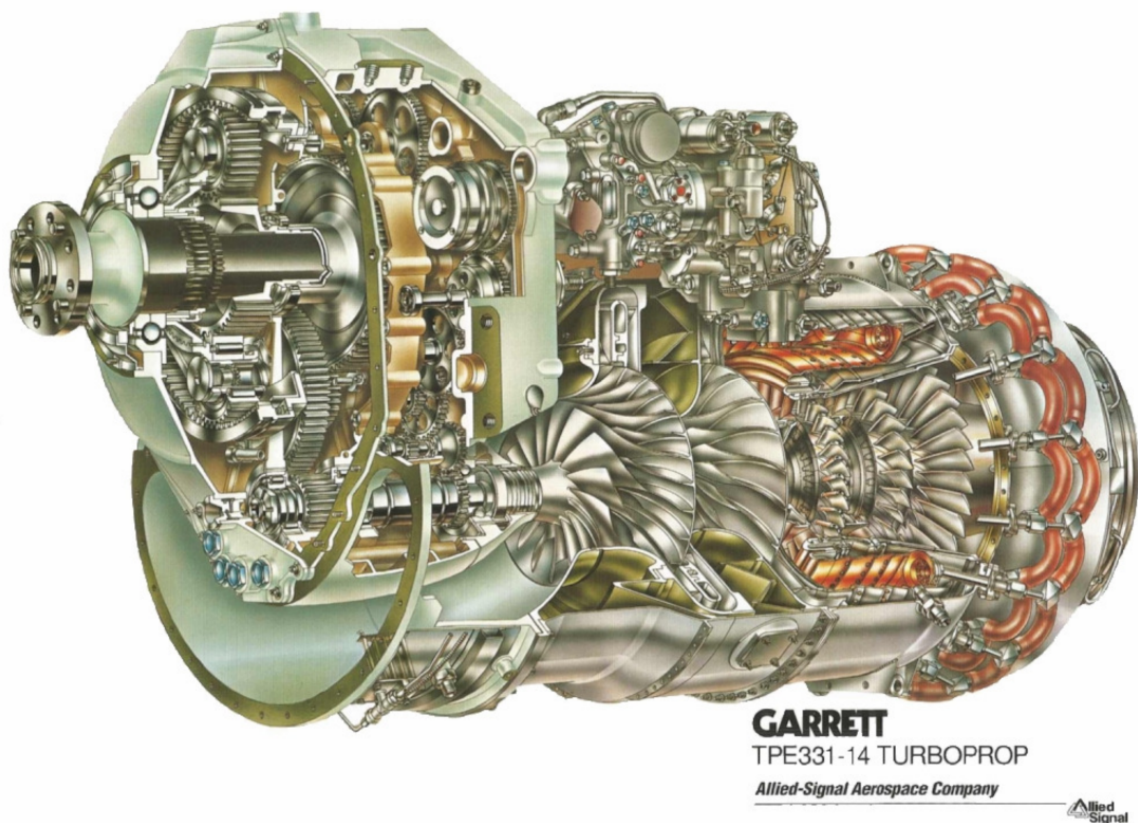
Figure 3. Garrett TPE331 turboprop engine cutaway drawing [20].

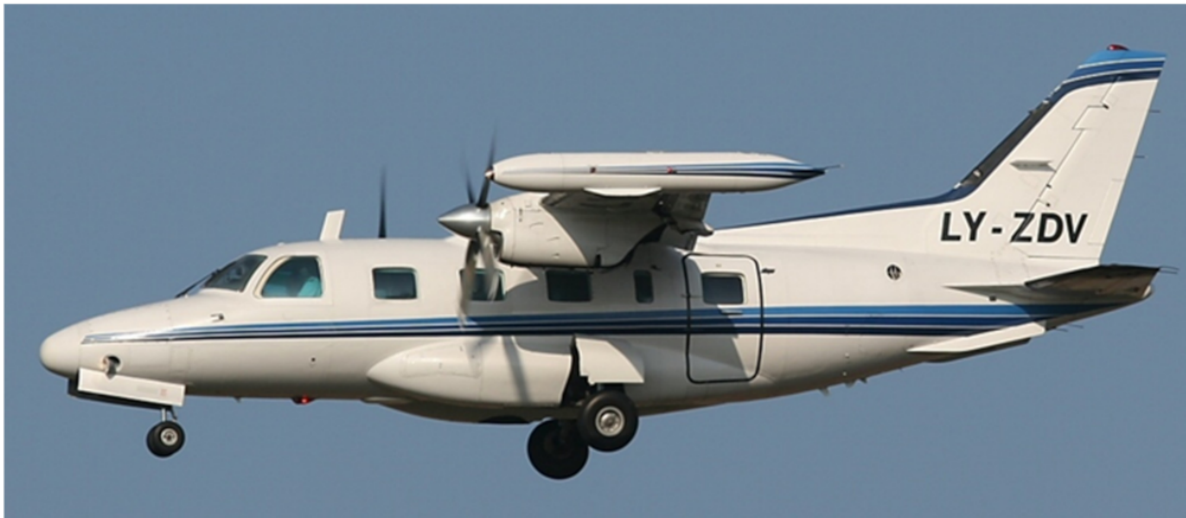
In the investigated crashes (Table 1), eight of the ten aircraft were Mitsubishi MU-2 aircraft. The Mitsubishi MU-2 is a twin-engine turboprop aircraft with a pressurized cabin (Figure 8). The aircraft is known for its difficult handling and high rate of accidents, including fatal accidents [23]. Crash numbers 7 and 8 with this aircraft were in icing conditions which may be relevant, given an Australian Bureau of Air Safety Investigation report on two fatal crashes on MU-2 aircraft, both of which were also in icing conditions [24]. However, even for the 1988 and 1990 fatal crashes in Australia, “icing on the airframe” was only listed as the “probable” cause and, for one of those two crashes, pilot fatigue was also referenced extensively. Thus, the reference to icing conditions in crash 7 in this investigation should be acknowledged but does not rule out cabin air contamination, either as a causal or contributory factor.

Figure 8. Mitsubishi MU-2B (Photograph by Alan Lebeda [25], trimmed, GFDL 1.2).
