Bachelorarbeit

Studiendepartment Fahrzeugtechnik und Flugzeugbau

Further investigation of engine performance loss, in particular exhaust gas temperature margin, in the CF6-80C2 jet engine and recommendations for test cell modifications to record additional criteria

LTQ Engineering Pty Limited
70 - 90 Garden Drive
Tullamarine, VIC 3043
Melbourne, Australia

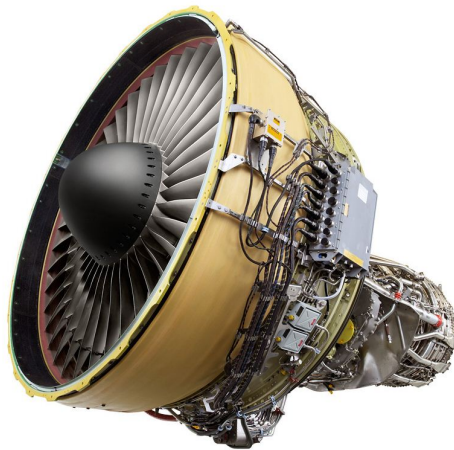
This investigation focuses on the decrease of EGT margin in the General Electric CF6-80C2 jet engine which is shown in figure 1.1. The problem of low EGT margin arises after

Figure 1.1: General Electric CF6-80C2 [GE10]

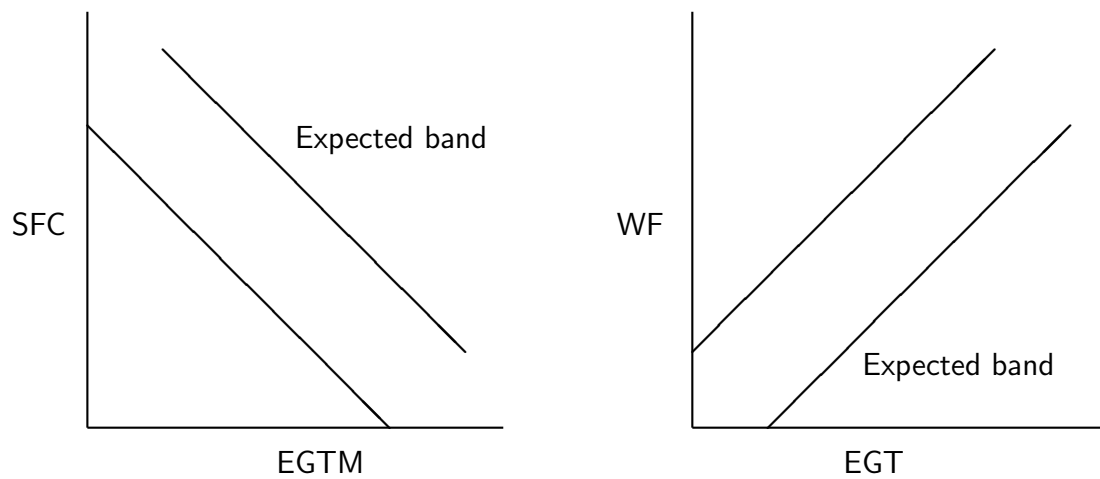
The chart on the left side of figure 2.4 shows the relationship between SFC and EGT margin. Normally high SFC results in low EGT margin and low SFC in high EGT margin which is presented by the expected band. If SFC is high, the engine burns more fuel to generate a certain amount of thrust or generates insufficient thrust for its fuel flow. If an engine is located in the area of high SFC and high EGT margin and outside of the expected band, an error in measurement of thrust or fuel flow is very likely. The chart on the right side of figure 2.4 displays fuel flow as a function of EGT. An increase in fuel flow results in a temperature rise due to the additional energy in the gas path [GE02]. Unfortunately it is not possible to determine one component for a high fuel flow or SFC, probable causes may lay in a poor fan, LPT, HPC and/or HPT performance [GE10]. Therefore it is necessary to have a look at other parameters to isolate the fault.

Figure 2.4: Relation between SFC and EGT margin and fuel flow and EGT [GE02]

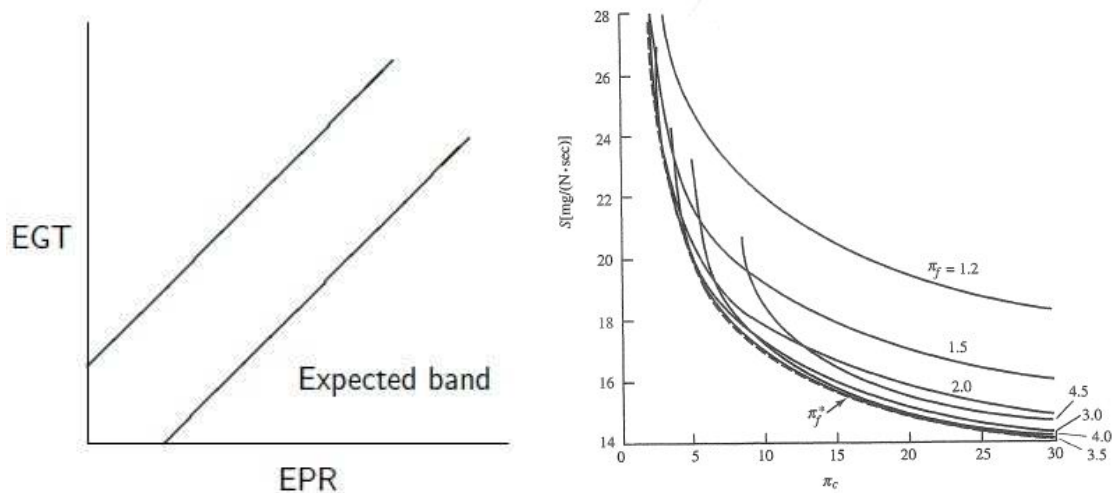
Engine pressure ratio (EPR) is usually measured between booster inlet and HPT outlet (between station 2 and 49, refer to figure 2.2). In the CF6-80C2, fan inlet pressure (P12) is used instead of booster inlet pressure due to availability [GE10]. Observing EPR has the advantage that it is directly proportional to engine thrust. A change of 1% in EPR results in a 1% change in thrust [BRÄ09]. Higher EPR results in higher thrust generation, which leads to a higher fuel consumption and therefore to an increase in EGT as explained in chapter 2.3. The chart on the left side of figure 2.6 shows the relationship between EPR and EGT.

Figure 2.6: EPR relation to EGT (left side)[GE02] and to SFC (right side)[MAT05]

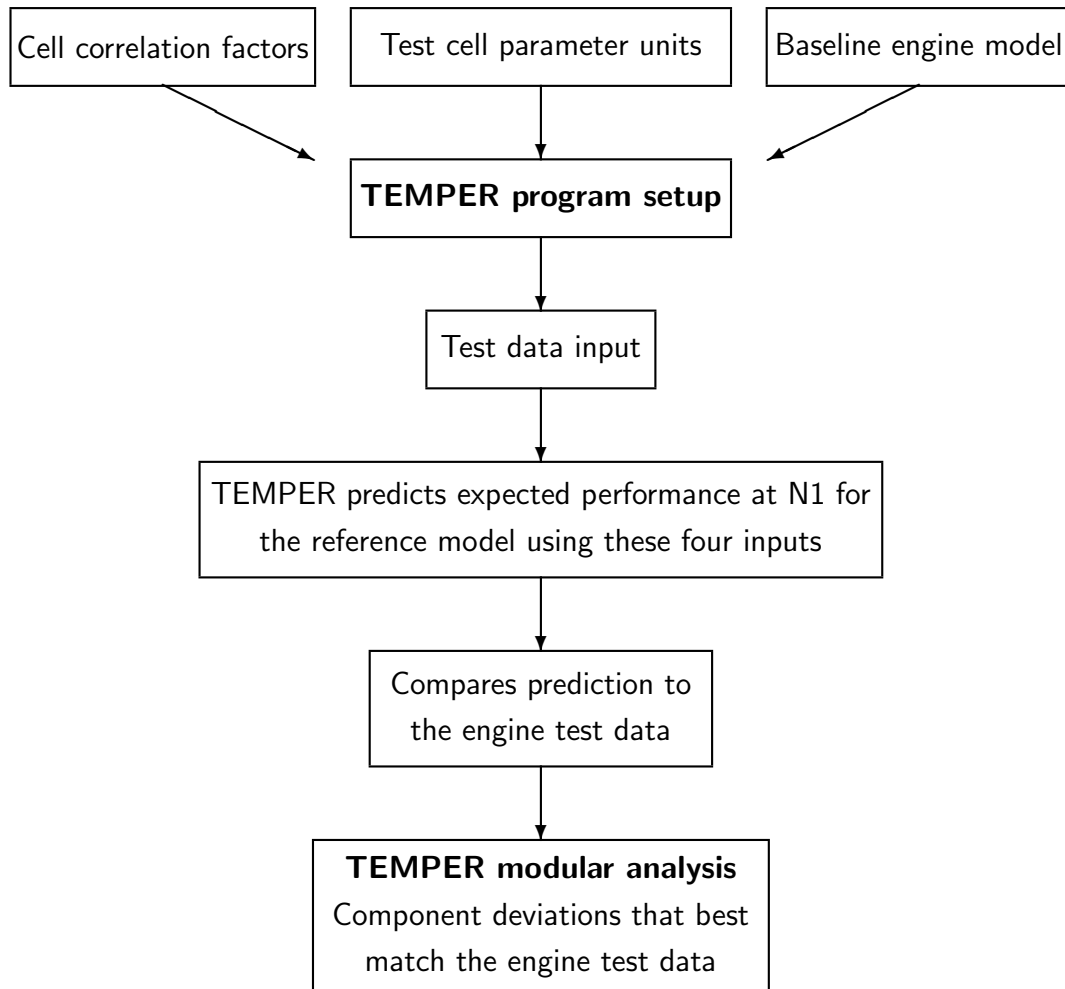
Figure 2.9: Flow-chart of the TEMPER process [GE02]

engine test data via email to the TEMPER program which calculates the entire thermodynamic cycle for both power settings (takeoff and maximum continuous) by using the measured fan speed (N1 rotor speed), fan inlet temperature and total pressure (T1A and P1A), barometric pressure and humidity. This prediction is compared to the engine test data and deviations are identified. Finally the TEMPER program creates the thermodynamic model by using the method of least-squares to provide component deviation which matches the test data at its best. The final report includes the effects of each module on EGT margin and SFC margin, deviation of the test cell data from the prediction before and after module assessment and the deviation of component flow and efficiency from reference baseline [GE02]. Appendix A.2 shows a TEMPER report for further information.

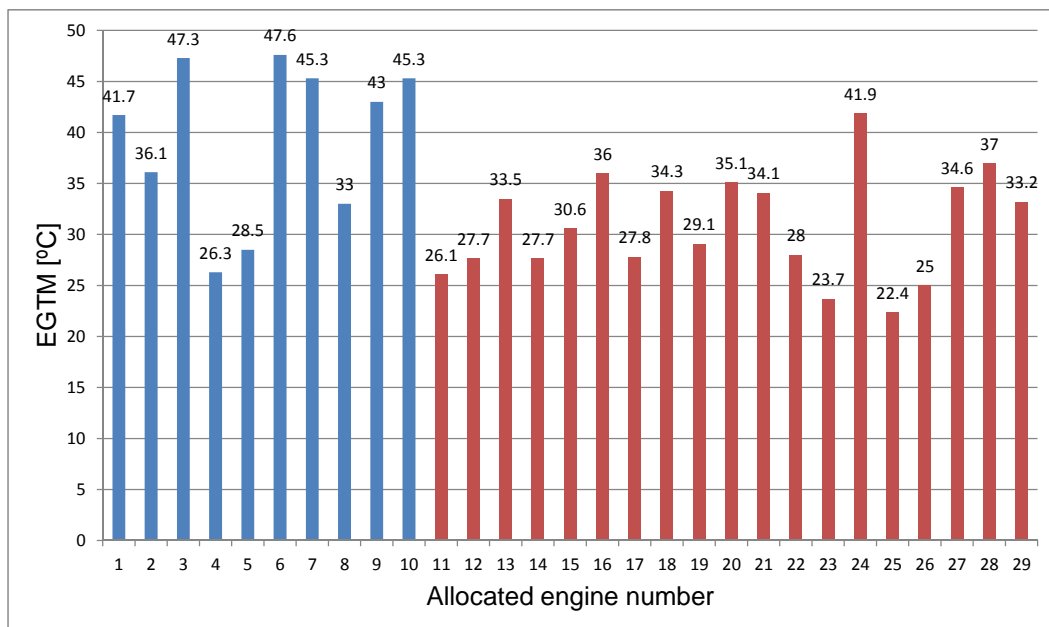
The effects of module performance on EGT margin and SFC margin of pre- and post-vendor engines are presented in this chapter. As mentioned in section 2.8, the TEMPER software presents the deviation in EGT margin and SFC margin on a modular basis. All engines in this investigation have passed through a full overhaul, therefore performance should be refurbished. The overall sample of engines consists of 29, whereby 10 are pre-vendor and 19 are post-vendor engines. Figure 3.1 and figure 3.2 compare pre- and post-vendor engines related to EGT margin and SFC margin. The blue bars are the pre-vendor engines, the red bars stand for the post-vendor engines. To allow a better comparison, each engine is allocated to a number. The numbers are assigned in chronological order to the time of overhaul. The pre-vendor engines have an average EGT margin of 39.4 °C, the post-vendor engines of 30.9 °C. It has to be mentioned that three pre-vendor engines (#4, #5 and #8) have a low EGT margin and four post-vendor engines (#16, #20, #24 and #28) a high EGT margin. However it is noticeable that the EGT margin has dropped with the change of the overhaul vendor. As the aim of this investigation is to find reasons for the performance deterioration and to identify possible changes in repair procedures, a comparison of pre- to post-vendor engines is more significant than of engines with high and low EGT margin. 70 % of pre-vendor engines reach the required EGT margin of 35 °C whereby it is only 21 % for post-vendor engines.

Figure 3.1: Comparison of EGT margin

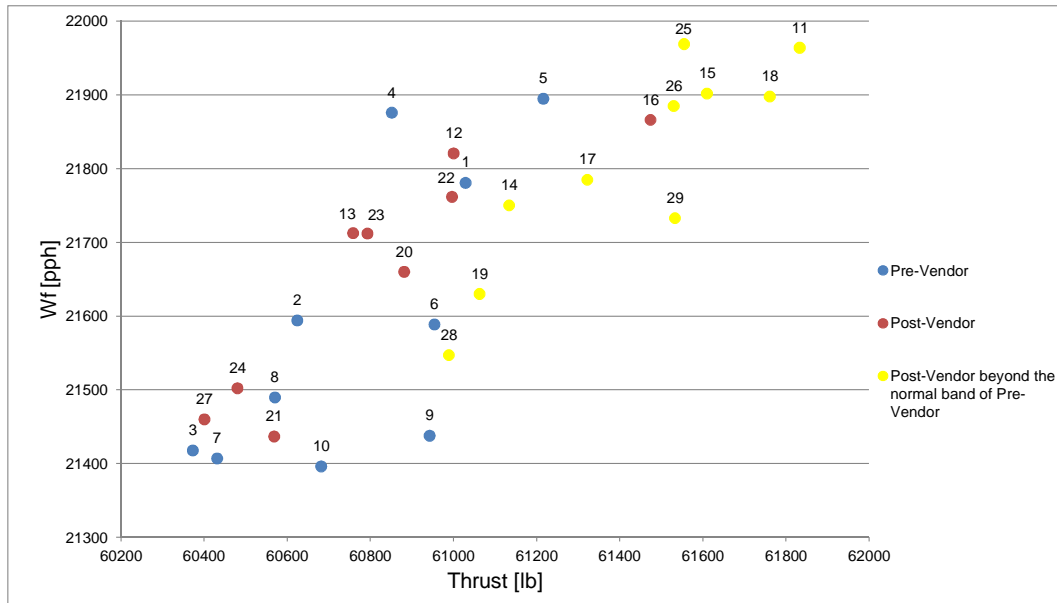
The yellow dots are the same post-vendor engines which are located beyond the normal band of pre-vendor engines in figure 4.1. Except for engine #28, they all have high SFC margin but do not reach the desired EGT margin of 35.0 °C. By comparing the two parameters, it becomes significant that most of them show higher thrust and fuel consumption. This explains the higher SFC margin but lower EGT margin; the high fuel consumption leads to high EGT, however the increased thrust generation results in low SFC and therefore high SFC margin. The position of engine #28 beyond the normal band of pre-vendor engines is explained by lower fuel flow but nevertheless higher thrust generation compared to engines in the same range. The same phenomena occurs to engine #19.

Figure 4.2: Fuel flow versus thrust

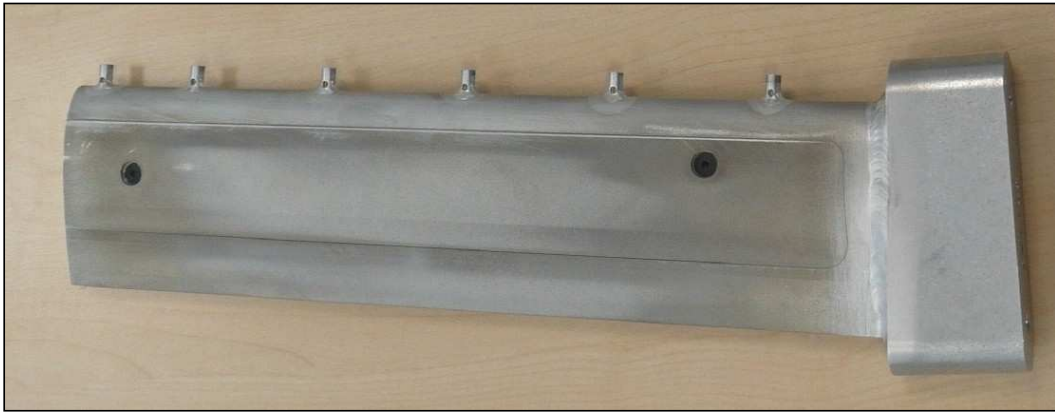
For measurement of pressure and temperature, both sensors are installed in rakes. An example of the rakes which should be used on the CF6-80C2 engines are shown in figure 7.4. The rake includes six pressure and/or temperature sensors and it is installed with its axis towards the direction of the gas flow. The six heads are called Kiel heads and they assure effective measurements despite greater incidence angles. However due to their size and small wall thickness, they are susceptible to damage during installation and removal [WF98]. Thermocouple sensors or resistance temperature detectors are the most common

Figure 7.4: Rake for temperature and pressure measurement

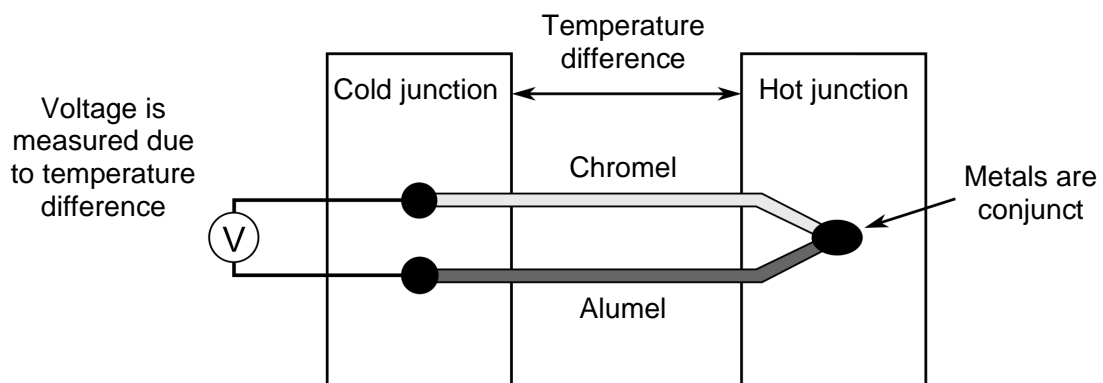
methods to measure temperatures in jet engines whereby they are applicable for different temperature regions. Thermocouple sensors are temperature sensing devices which use voltage generation due to temperature difference and different metal alloys. As the temperature at the measuring point increases or decreases, the millivolt value of the sensing elements increase or decreases accordingly [GE03]. Figure 7.5 shows a schematic diagram of a thermocouple sensor. The Type K thermocouple sensors are the most common type

Figure 7.5: Schematic assembly of a thermocouple sensor (Type K) [WIK11]
