Proceedings of the 21st European Conference on Composite Materials

INVESTIGATIONS ON THE INFLUENCE OF DESIGN PARAMETERS ON THE STRENGTH OF CFRP REPAIRS

Keywords: Carbon fibre reinforced plastics (CFRP), bonded repair, EN6066, Cupped, Straight

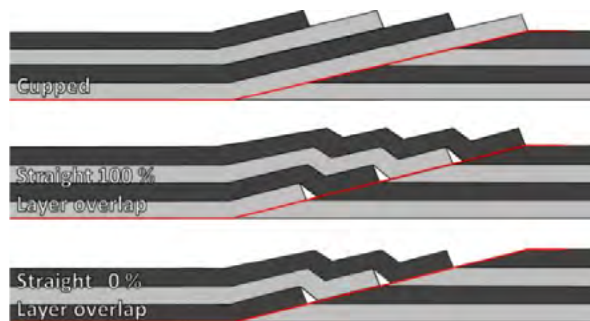
Figure 2: Sketch of repair configurations Cupped, Straight 100% and Straight 0% overlap according to [7]

In the Straight configuration, depending on the accuracy of the ply cutting and the positioning precision, the attachment of a repair ply to the parent material can occur with a ply of the same fibre orientation or one with a different fibre orientation. Depending on this, the Straight repair configuration is additionally defined with a percentage indicating the degree of overlap.

A bonded repair that does not require material doubling necessitates scarfing of the repair area. This study exclusively considers straight-scarfed repair areas. Based on this, two basic variants of a repair configuration can be defined. On the one hand, repair plies with decreasing diameters can be sequentially applied to the repair area. This configuration is referred to as "Cupped." On the other hand, repair plies with increasing diameters can be introduced into the repair area. In this configuration, the repair plies remain straight in the lateral cross-section, hence this configuration is termed as "Straight."

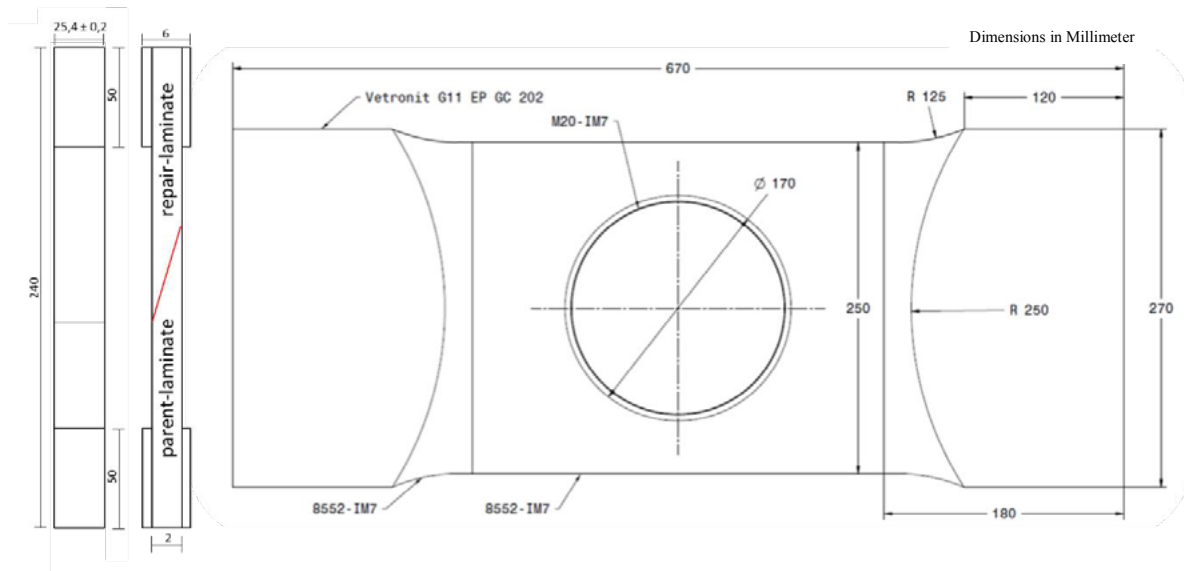
Figure 3: l. to r. sketch of specimen EN6066 top view, EN6066 side view and 2,5D top view

Both types of specimens feature fibreglass-reinforced plastic (GFRP) tabs in the clamping area. The parent laminate consists of unidirectional (UD) prepreg Hexply 8552-IM7 from Hexcel (Hexcel Corporation, Stamford, Connecticut, United States). The repair laminate utilizes UD prepreg Hexcel M20-IM7 from Hexcel (Hexcel Corporation, Stamford, Connecticut, United States). The adhesive used is Hysol® EA 9695™ 050K AERO with a 240 g/m² area weight, including a knit supporting carrier (Henkel AG & Co. KGaA in Duesseldorf, Germany).

These repair configurations were examined at the coupon level using the EN6066 test specimen. This specimen represents a simplified geometry of a real repair, where the repair area is simplified to a straight scarfing over the width of the specimen, resulting in a skewed 2-dimensional surface for the adhesive area. Additionally, this specimen does not include the use of so-called "cover plies," which are required for repairs according to the Structural Repair Manual (SRM) [8]. At the next level of the testing pyramid, the repair configurations were examined using Airbus's own 2,5D specimen geometry. This specimen features a circular straight scarf of the repair area, resulting in a 3-dimensional curved surface for the adhesive area. However, the parent laminate remains a flat plate, thus not accounting for the typically curved shape of an aircraft's outer skin structure. Nevertheless, this specimen includes the cover plies required by the SRM, making it a significantly more realistic representation of a real repair. The following figure depicts the EN6066 specimens in the top view and a side view on the left side, while the 2,5D specimen is shown in the top view on the right side.

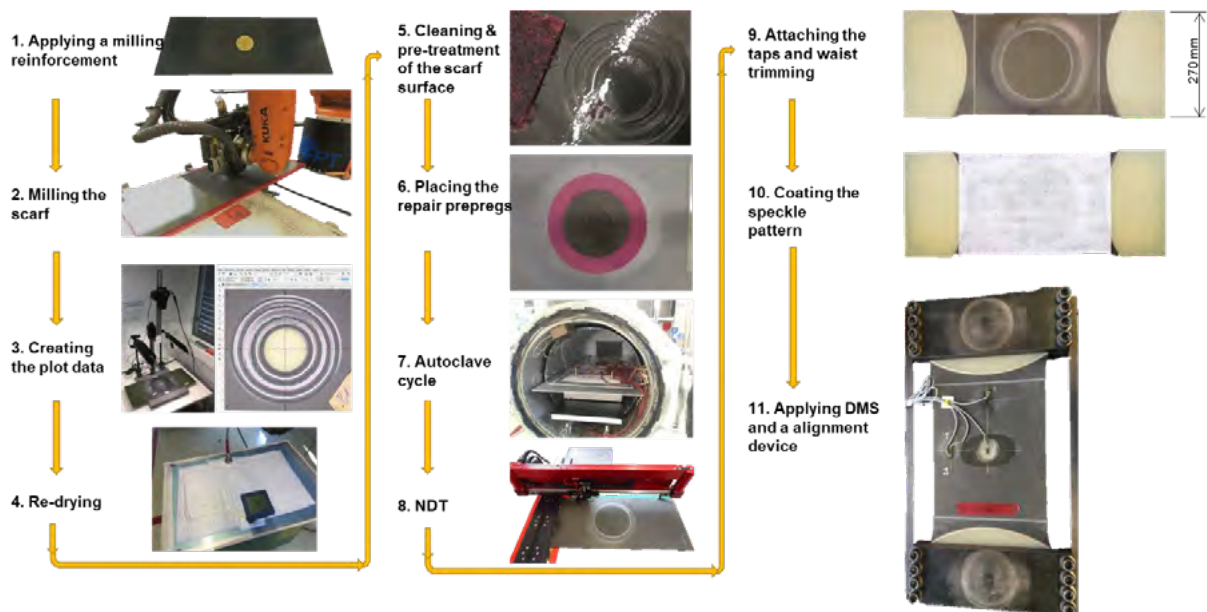
Figure 4: Manufacturing process of a 2,5D specimen

Since the manufacturing process of the different specimen types largely follows the same steps, the fabrication process of the 2,5D specimens is described below. Firstly, the CFK plates of the parent laminate are produced using hand lay-up techniques. Curing takes place in an autoclave according to the manufacturer's specifications [9]. Subsequently, a GFRP reinforcement plate is applied to the backside of the repair area. This serves to support the fibres during the milling process, reducing fraying of the bottom fibre layers. Next, the scarf is milled. The surface is initially measured using a distance laser and then milled using a 6-arm articulated robot. Following this, an analysis of the scarf pattern is conducted (see Chapter 2.2 Specimen analysis: Overlap), based on which the repair ply cutouts are generated. Before the actual repair begins, the parent laminate is dried to ensure a comparable initial state of the parent laminates. After drying, the repair area is cleaned with isopropanol and then pretreated with a 3M Scotch-Brite +7447 abrasive pad. Subsequently, the repair area is cleaned again with isopropanol and allowed to air-dry for at least 30 minutes. This is followed by the application of the film adhesive and repair plies, with a "debuckling process" occurring for 5 minutes after every 4 plies. After the application of all repair plies and cover plies, the repair is cured in an autoclave process. To assess the repair quality and ensure that the bonding is not affected by pores or other defects, an ultrasound scan is performed. If the repair quality is sufficient, the tabs are attached, and the specimen is trimmed to have a narrower width in the test area to ensure targeted fracture in the repair area. Shortly before testing the specimen in the testing machine, a black and white speckle pattern is painted on the specimen, which is required for the generation of digital image correlation (DIC) data. Lastly, strain gauges are applied to the backside of the specimen, and an alignment tool is attached by screws. The described manufacturing process and the test-ready specimen are shown in the following figure 4.

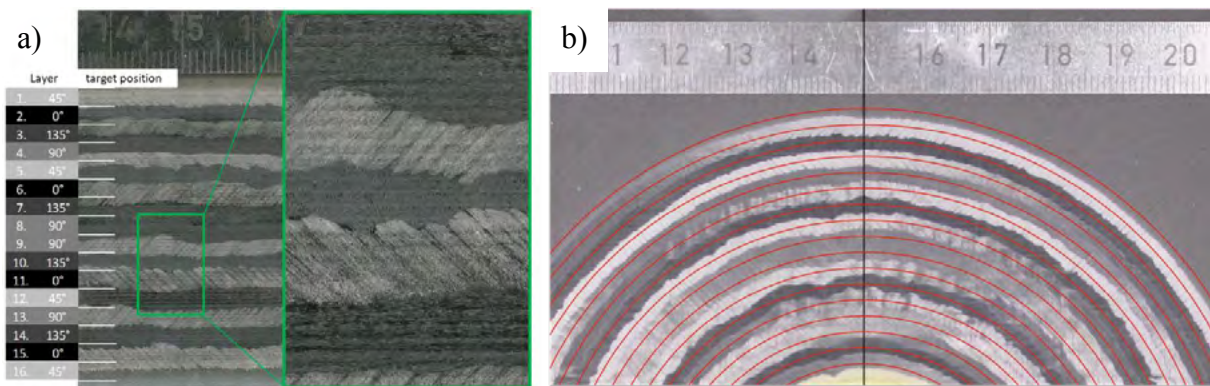
Figure 5: Deviations in scarfing pattern, a) EN6066, b) 2,5D specimen

The deviations in the scarfing pattern of the parent laminate can stem from various sources. Beginning with the possible waviness of the prepreg plies in the parent laminate. Additionally, gaps between two prepreg plies within a layer can exert influence. The relative height position of a ply within the laminate as well as variations in ply thickness itself are potential causes associated with the parent laminate. Furthermore, deviations in the milling process may result from elastic deflection of the mill or the laminate. Moreover, it cannot be ruled out that the robot may approach certain positions with higher repeatability than others.

The degree of overlap depends not only on the accuracy of the repair ply cutouts and their positioning precision but also on the conditions in the repair area, known as the "scarfing pattern." Figure 5 depicts, on the left side, a schematic representation of the nominal positions of individual plies in the scarfing

pattern for an EN6066 specimen. The white lines represent the nominal positions extending into a photo of an EN6066 scarfing pattern, indicating significant deviations from the theoretically expected straight lines. This is magnified for an extreme range (green border). Similarly, in the analysis of the circular scarfing of a 2,5D specimen, as shown on the right side of Figure 5, the nominal positions of the ply rings are indicated by red lines, illustrating significant discrepancies between the theoretical scarfing pattern and the actual one. This necessitates an adjustment of the ply cutouts and layup positions of individual repair plies to achieve the desired overlap degrees of 0% and 100%. This adjustment constitutes step 3 in Figure 4. For the EN6066 specimens, an additional configuration was fabricated where no ply adjustment were made, and instead, the repair plies were applied according to the theoretical nominal positions.

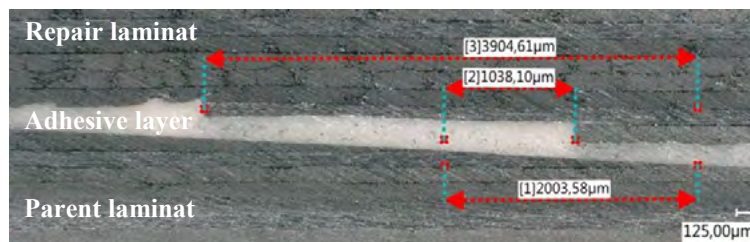
Figure 6: Method to determine the degree of overlap

Figure 6 illustrates the method used to determine the degree of overlap for the Straight configurations. Firstly, the projected length of the ply within the scarfing is measured (2003.58 μm). Subsequently, the length of the repair ply with the same fibre orientation is measured, specifically the portion that is in direct contact with the corresponding ply in the parent laminate and not influenced by another ply (1038.10 μm). The quotient yields the percentage overlap for this particular repair ply. Following this methodology, the following measurement results are obtained for the degree of ply overlap of the Straight configurations for the EN6066 specimens.

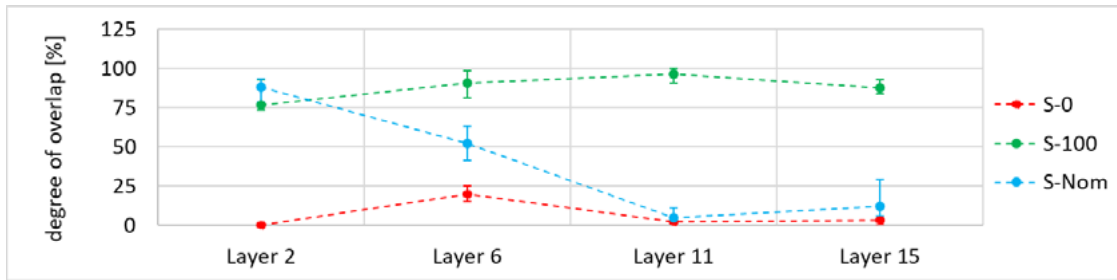
Figure 7: Result of analyzing the degree of overlap of the 0° Layers from EN6066 specimen

Manufacturing exact overlap is very challenging due to the numerous influencing factors that deviate the scarfing pattern from the theoretical one, coupled with the requirement for positioning accuracy to approach practically zero tolerance. Nevertheless, good accuracy for the overlap grades of the EN6066 specimens could be achieved. The results of the tensile tests demonstrate a significant influence of the repair configurations on the fracture strength. However, it is important to note that the overlap grade directly affects the size of the bonding area, and therefore, the influence of the varying bonding area must be considered alongside the overlap grade.

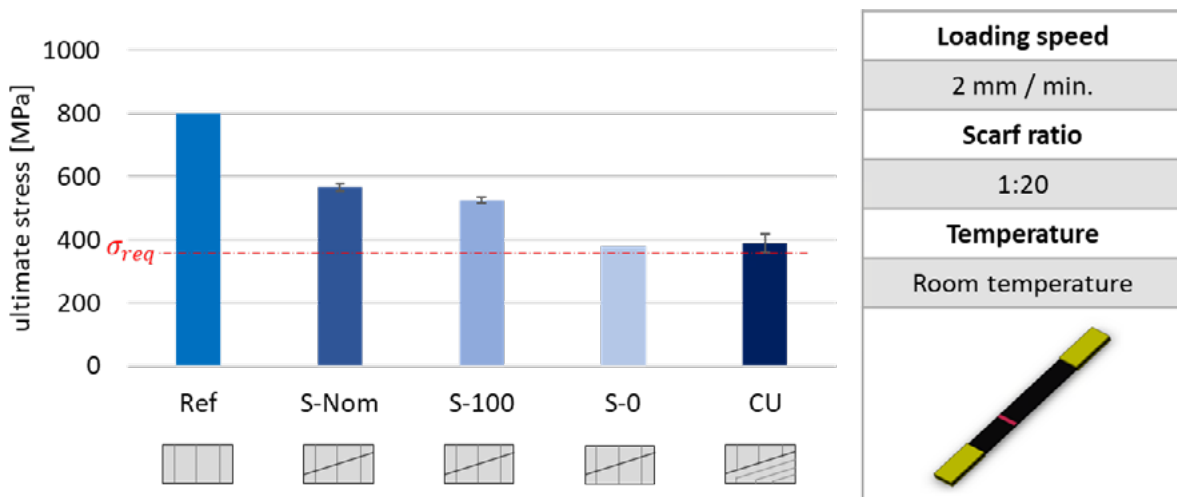
Figure 8: Ultimate stress of EN6066 specimen

It should be noted that the effective adhesive area also varies due to the different degrees of overlap and therefore the utilisation of the theoretical adhesive strength is not considered. If this is done, the configuration Straight 100% achieves the highest utilisation of the theoretical adhesive strength.

The results of the quasi-static tensile tests are presented below regarding the fracture strength. The measured maximum force is divided by the nominal cross-sectional area of the parent laminate, as prescribed by the standard [10]. The diagram in Figure 8 illustrates the fracture strength of the EN6066 specimens. The results of this study on 2mm laminates are shown. Additionally, the required strength is denoted as σ_{req} , is indicated. This required strength is achieved by all configurations. As expected, the highest strength is exhibited by the reference specimen, which consists only of parent laminate and does not involve bonding or repair. The Straight 0% and Cupped configurations barely achieve the required strength. The Straight 100% configuration averages 525 MPa, while the Straight variant with nominal dimensions (S-Nom) averages 565 MPa.

At Coupon level, the test result of the EN6066 specimen shows a significant influence of the repair configuration. Cupped and Straight 0% configuration just achieve the required strength. Straight with $\geq 100\%$ overlap degree reach a strength minimum 45% higher than required. If the variation of the adhesive area, due to varying repair configurations is considered, the configuration Straight 100% is the best one tested.

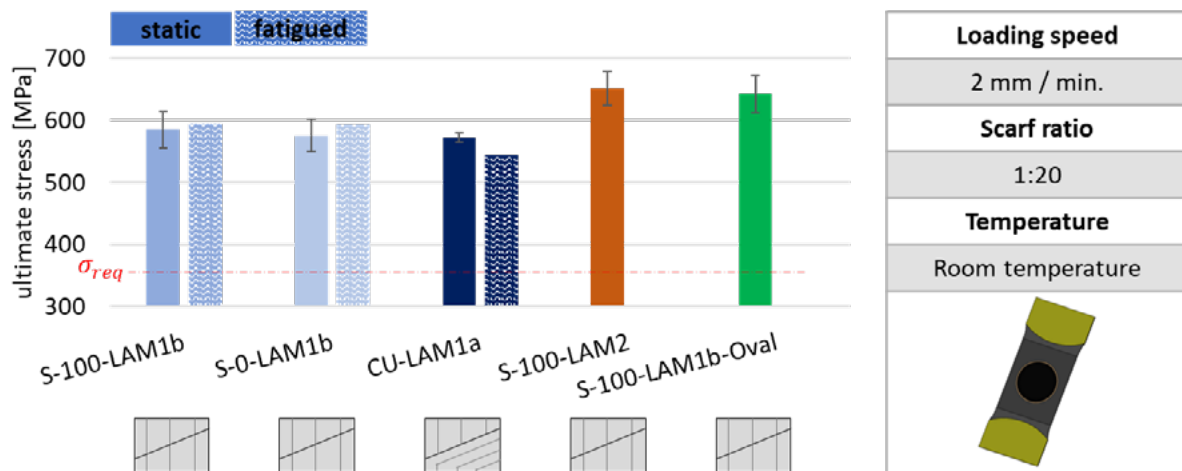
Figure 9: Ultimate stress of 2,5D specimen

A clear distinction in the influence of repair configurations between EN6066 and 2,5D specimens can be identified through DIC data. This data reveals that the 2,5D specimen bends in the laminate thickness direction under tensile loading. This bending leads to superimpose of tensile strain and bending-induced compression, creating a region within the repair area experiencing reduced tensile strain. Simultaneously, this bending generates a bending moment that increases towards the clamping region, subjecting the specimen to higher stress immediately before the grips than in the test region. As a result, some of the 2,5D specimens did not fracture in the repair area but rather near the clamping region. The cause of this phenomenon can be attributed to the presence of the cover plies, which create an asymmetric cross-section of the specimen along its longitudinal axis. Under tensile loading, the specimen attempts to align its centre of mass with the line of force flow, inducing bending in the thickness direction.

The 2,5D specimens show a completely different result about the influence of the repair configurations. For example, the fracture strength for Straight 0% and 100% is the same, regardless of whether the

specimen was directly subjected to a quasi-static test or was subjected to a fatigue test with parent laminate strain of $4000\mu\text{m}/\text{m}$ for 54000 cycles prior to the quasi-static test. In addition, the cupped configuration exhibits only slightly lower fracture strengths. In addition, it is found that oval scarfing, where a higher scarf-ratio is used in the loading direction, leads to an increase in fracture strength. In the case of Straight 100%, the specimen labelled S-100-LAM2 also shows a higher fracture strength compared to S-100-LAM1b, indicating that the layout of the parent laminate is also a relevant parameter for the strength of a CFRP repair.

The 2,5D specimens show no significant influence of the repair configurations on the fracture strength. One explanation for this may be the parent laminate surrounding the repair, as this is so strong that the influence of the different repair configurations is not reflected in the ultimate stress. Additionally, it is likely due to the influence of the cover plies and the associated asymmetrical cross-section of the 2,5D specimen. As a result of this, the specimen bends in the thickness direction, causing unilateral compression of the specimen. This leads to a region of reduced tensile strain in the repair area due to the superposition of tensile strain and bending-induced compression. Furthermore, the bending of the

The 2,5D specimen, which is a more realistic representation of a real repair, shows no significant influence depending on the repair configuration. Here, the influence of the parent laminate surrounding the repair is probably so strong that the differences in the repair configuration are not significantly reflected in the ultimate stress. Additionally, this can be caused by the use of cover plies, which are required from SRM [10] for a convincing repair but influences the cross-section of the specimen in a manner, that an undesired bending of the specimen occurs. This results in a less high-stress level in the repair area of the specimen and caused some of the tested 2,5D specimens to fail near the clamping of the specimen rather than the desired fracture in the repair area. Future use of this specimen should rethink the shape of the taps (see Figure 3) since, the rounded shape led to partial failure of the bonding of the taps itself. The use of cover plies should only be considered if the behaviour of a real repair is wanted. If the influence of different repair configurations is to be analysed, no cover plies should be used since the resulting asymmetric cross-section of the specimen generates a disturbing bending of the specimen. Alternatively, the waist trimming could be done more strongly to ensure the breaking of the specimen in the desired area.
